# USS NASHVILLE (LPD-13) SEMAT II HULL AND SUPPORTING STRUCTURE SURVEY

7/22/02 TO 8/2/02

**USS NASHVILLE (LPD-13)**  
**SEMAT II**  
**SHELL AND SUPPORTING STRUCTURE SURVEY, INTERIOR AREAS.**

A SEMAT II UNDERWATER HULL AND SUPPORTING STRUCTURE SURVEY OF INTERIOR AREAS WAS CONDUCTED ON BOARD **USS NASHVILLE (LPD-13)** FROM 07/22/02 TO 08/02/02 AT NAVAL STATION, NORFOLK VIRGINIA.

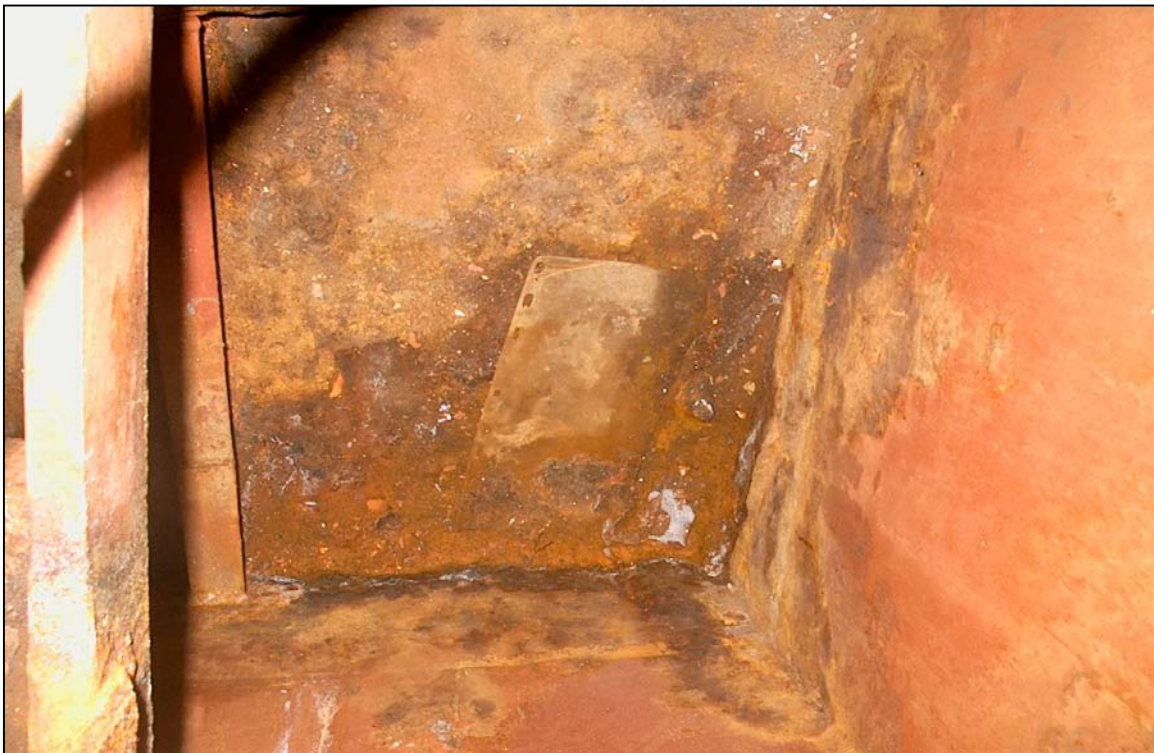
**USS NASHVILLE (LPD-13)  
FORWARD PUMP ROOM (8-44-1-E)**

PUMP AT BHD 52. ENTIRE SPACE HAS MILD CORROSION AND PAINT FAILURE.  
ARROW INDICATES CORROSION BELOW.

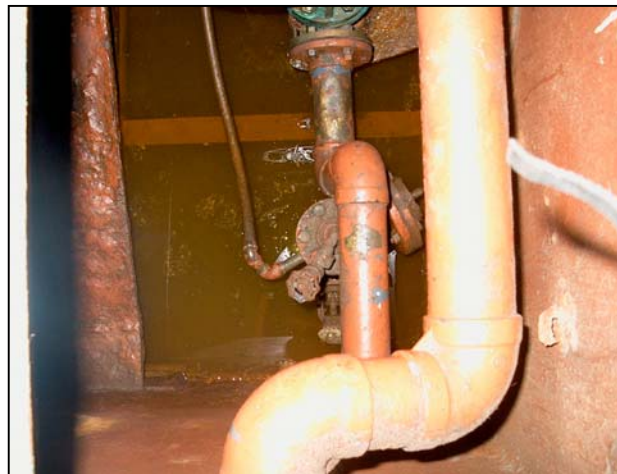
**TRAPPED WATER IS THE MAIN CAUSE  
OF CORROSION.**

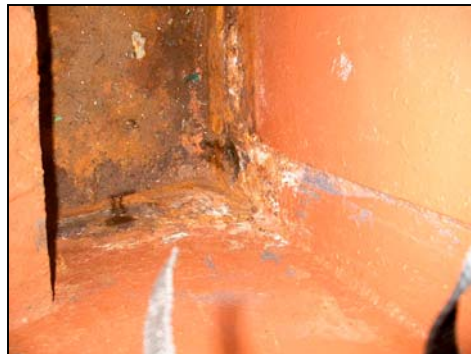
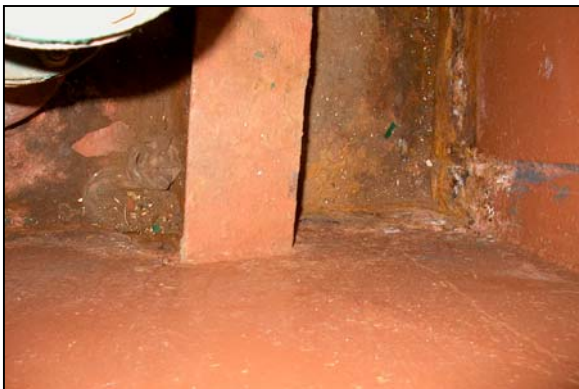
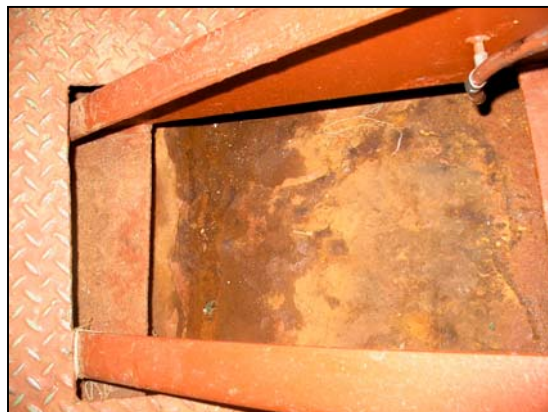
<b>(8-216-1-E)</b> GAS SYSTEMS SALT WATER PUMP ROOM <b>JSN A370</b>	STBD SHELL AND STRINGERS BETWEEN BHDS(216-226)	APPROX. 100 SQF OF MILD CORROSION.
<b>(4-160-3-E)</b> A/C MACHINERY ROOM 1 <b>JSN A369</b>	STBD SIDE AT BHD (160) TANK TOP BELOW BOTTLE RACK.	TANK TOP THINNED BELOW THE 25% WASTAGE CRITERIA
<b>(4-52-1-E)</b> EMERGENCY DIESEL GENERATOR ROOM NO.1 <b>JSN A366</b>	DECK, SHELL AND BHD (68) AFT OF ELECTRICAL PANELS	APPROX. 50 SQFOF CORROSION.

**CORROSION ON THE SHELL AND STRINGERS  
BETWEEN FRAMES (216-220). JSN A370**
